**DOT/FAA/CT-92/04**

# **Commuter/Air Taxi Ditchings and Water-Related Impacts that Occurred from 1979 to 1989**

July 1994

Final Report

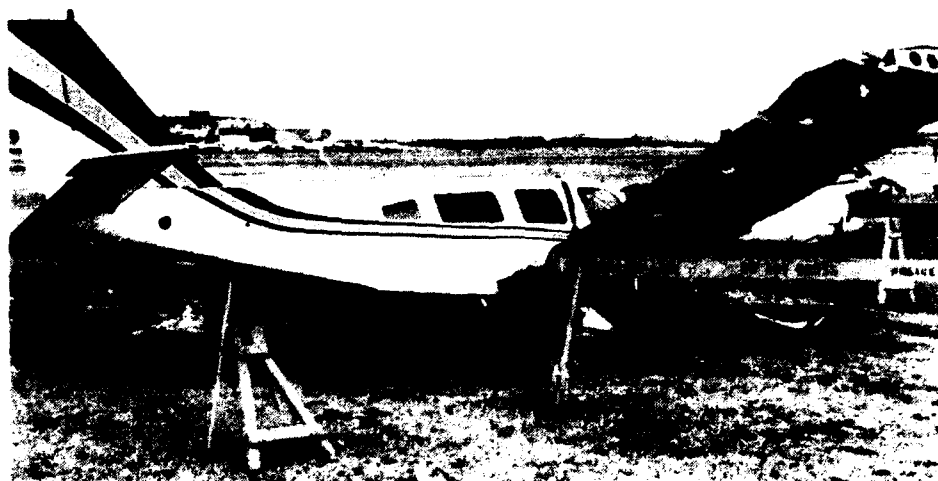
FIGURE 4.12. CASE STUDY 6, FULL VIEW OF RIGHT FUSELAGE DAMAGE

- a. Left wing completely separated from fuselage and inverted (figure 4.11).
- b. Forward upper left fuselage side indentation resembling left wing tip (figure 4.11).
- c. Fuselage door under the wing (figure 4.11).
- d. Left, right, and nose gear in down position (figure 4.12).
- e. Nose wheel and lower part of nose strut missing (figure 4.11).
- f. Right wing tip missing (figure 4.12).
- g. Rudder slightly wrinkled.
- h. Nose crush damage (figure 4.11).
